NEWPORT NEWS SHIPBUILDING CO VA F/G 13/10  
FURTHER SURVEY OF IN-SERVICE PERFORMANCE OF STRUCTURAL DETAILS.(U)  
MAY 80 C R JORDAN, L T KNIGHT DOT-CG-75172-A

SSC-294

**APRIL 1980  
SR-1258**

16. Abstract This project is an adjunct to the Ship Structure Committee report SSC-272. Using the same survey techniques and data analysis procedures described in that report, the midship/cargo areas of an additional twelve bulk carriers, twelve containerships, and twelve general cargo ships were surveyed under Project SR-1258. The goal of both projects is to provide design and repair personnel with structural service data and recommendations that can be used to significantly decrease the number of detail failures that occur on ships of all types. The data from both surveys are combined and summarized for ready use by design and repair offices.  Structural detail failure data were collected for twelve detail families (beam brackets, tripping brackets, non-tight collars, tight collars, gunwale connections, knife edge crossings, miscellaneous cutouts, clearance cuts, deck cutouts, stanchion ends, stiffener ends, and panel stiffeners) to provide guidance in the selection of structural detail co

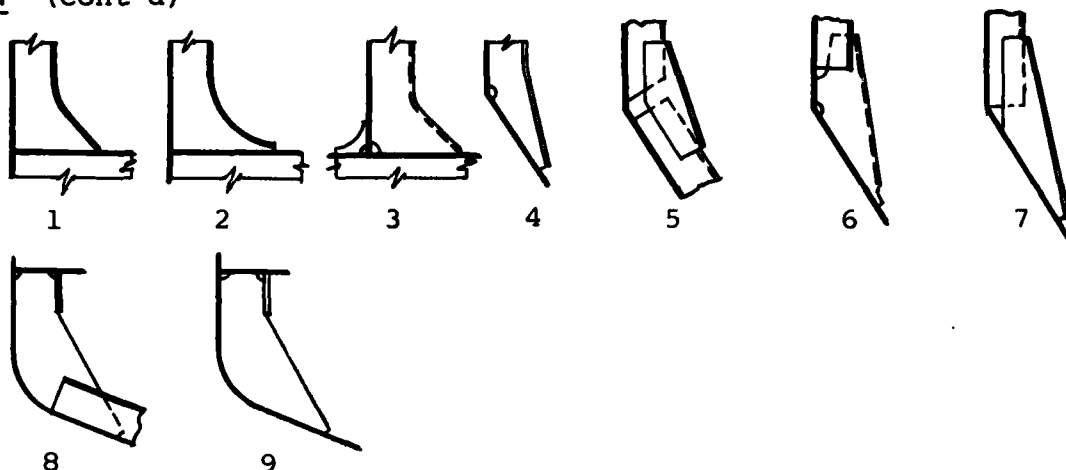
P.

The transition brackets of family group "M" were quite common near the turn of the bilge and, thus, were quite susceptible to corrosion. Proper design, such as drain holes to prevent standing water and elimination of inaccessible areas, coupled with a regularly enforced maintenance program, would have prevented failures in this area.

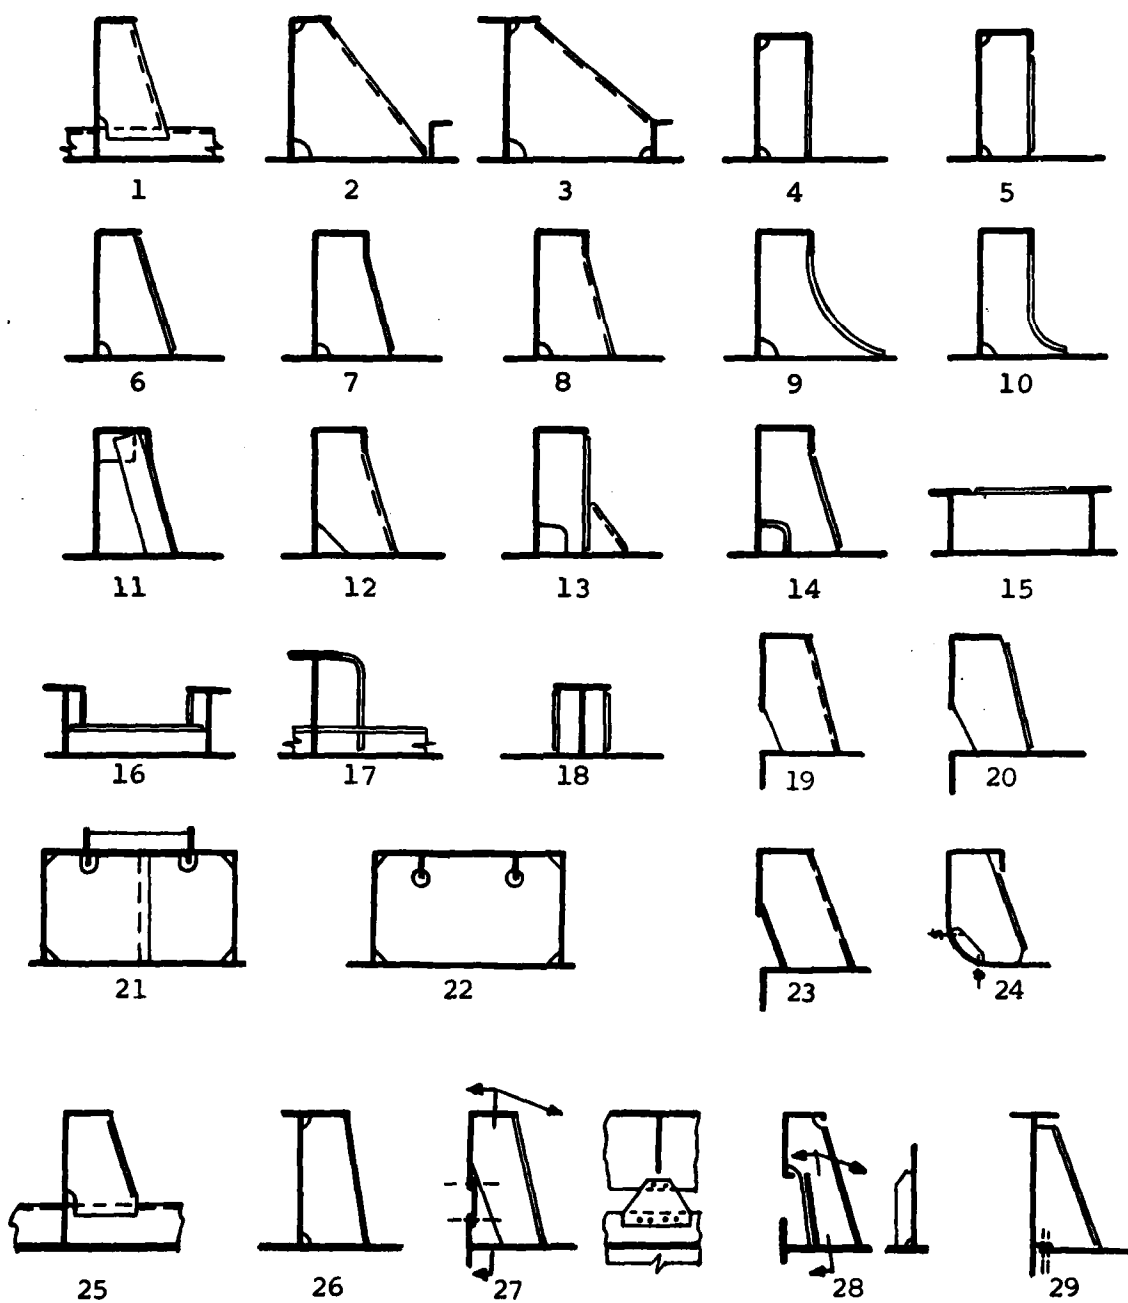
C.

Details 2-C-19 and 2-C-20 sustained a high number of failures for several reasons. Poor welding, neglect, cargo collisions, and misuse/abuse were a few causes, but a consistently high percentage of failures occurred where these details were used to secure the booms of general cargo ships when at sea. These details are typical of the tripping brackets used to support the bulwark that runs fore/aft just above the gunwale on both sides of the ship. Tie-down cleats welded to the top of this bulwark make very convenient securing points for the huge booms. When under heavy weather at sea, large shear and tensile forces are applied to the tripping brackets due to the athwartship "G" forces of the heavy booms. Failures even occurred when an extra flange was added to the bracket as in detail 2-C-23. The surveyors did find, however, that on ships where extra tripping brackets and larger scantlings were used under boom tie-downs, no failures occurred.

The high number of failures for detail 2-C-11 resulted primarily from poor fabrication/workmanship. On several general cargo ships, this tripping bracket was used to support the hatch coaming girder on main deck and was partially removed by the ship's crew in order to replace existing pipe that runs alongside the hatch coaming. In replacing the lower half of the tripping bracket, the crew's workmanship was poor. Poor lap welding, sharp notches and very rough cutouts for the pipe quickly developed corrosion and cracks.

Details 2-C-7 and 2-C-8 on both containerhips and bulk carriers continue to contain failures when located on the transverse ends of the hatch coamings. Observed failures of details 2-A-20, 2-C-4, and 2-C-26 increase significantly the total list of failures observed for hatch coaming brackets. Heavy seas, welding, neglect and cargo collisions, combined with poor design, have made the task of supporting the hatch side girders a costly one. Additionally, it is necessary to design brackets to carry large lateral loads from rolling when the containers are stacked in four tier heights. Proper design, as shown in detail 2-C-9, should also allow for a smooth transition for the load to travel from the tripping bracket to the back-up structure below. The surveyors noted on several occasions that detail 2-A-20 had been repaired by adding a radiused extension at the toe of the bracket to reduce subsequent failures. This smooth transition provided by the radiused extension is most important when the bracket lines up with the fore/aft hatch side girder. When the fore/aft header, forming the back-up structure for the bracket, reaches the coaming girder there is a significant increase in inertia. Such an abrupt change in stress flow increases crack susceptibility, as was the case 80% of the time.
